DEGRADATION OF COATING ALLOYS  
IN SIMULATED MARINE ENVIRONMENTS

R.H. Barkalow and F.S. Pettit  
Pratt & Whitney Aircraft Division  
United Technologies Corporation  
400 Main Street  
East Hartford, Connecticut 06108

15 June 1978

Final Report: 1 March 1976 to 1 March 1978

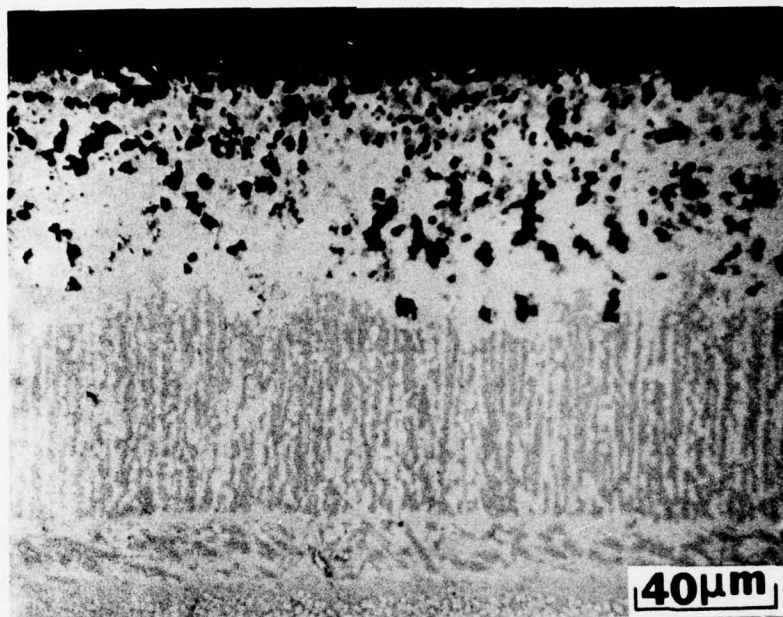
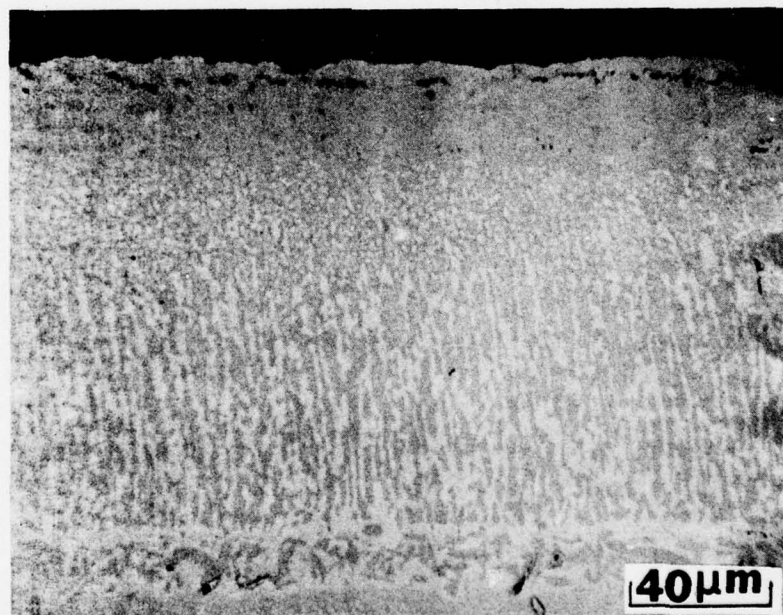
Figure 52. Variable extent of microstructural degradation after 940 hours exposure of PWA 68 + Pt + PWA 273 coating in 899°C cyclic hot corrosion.

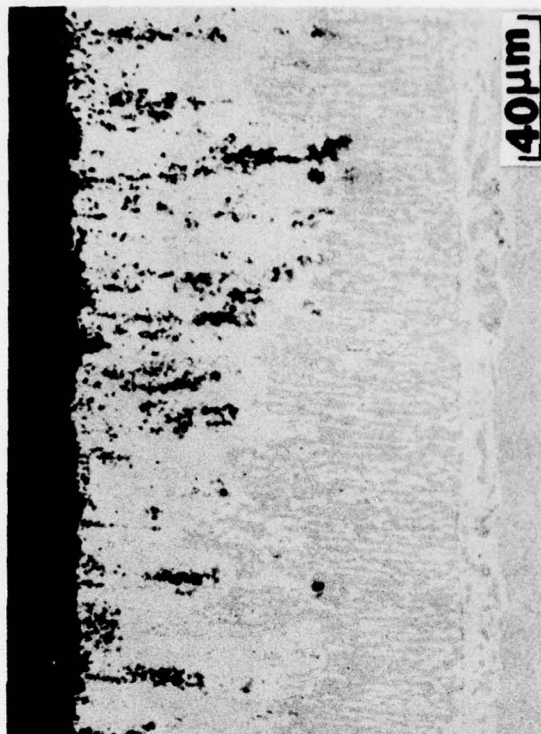
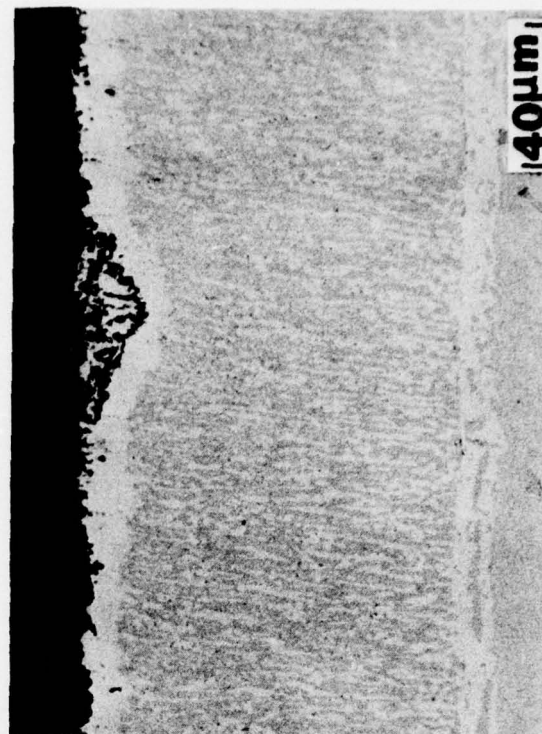
Figure 53. Surface condition and microstructural degradation of Ti-modified PWA 68 coating; exposure time = 520 hours in 899°C cyclic hot corrosion with  $\text{Na}_2\text{SO}_4$  - 50% NaCl.

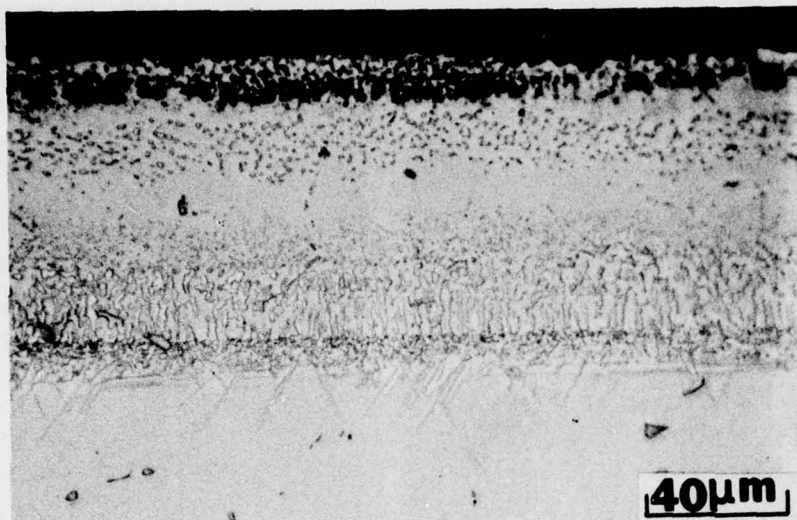
Figure 54. Microstructure of Ti-modified PWA 273 (6μm layer of sputtered titanium applied prior to aluminizing) after 1000 hours of cyclic hot corrosion testing at 899°C with  $\text{Na}_2\text{SO}_4$  - 50% NaCl

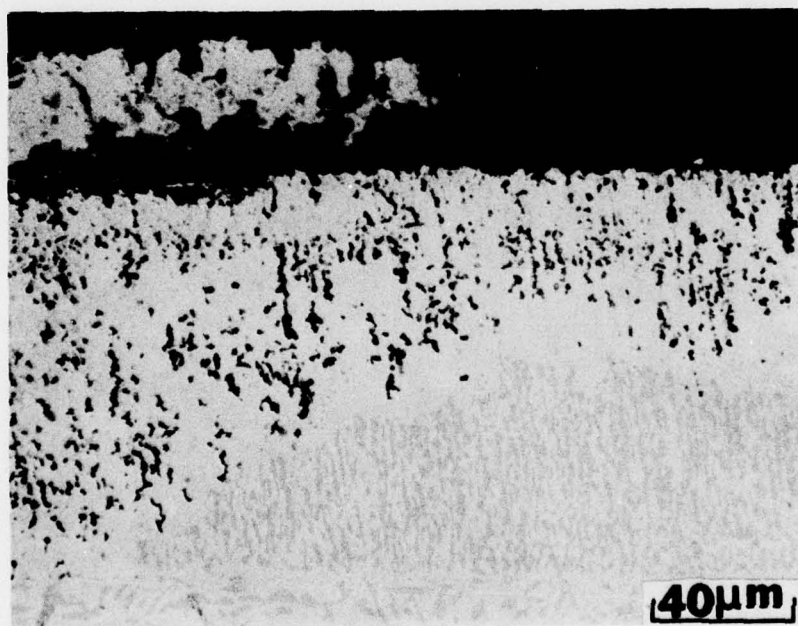
Figure 55. Oxidation of Ni overlayer and dealloying of PWA 68 after 80 hours exposure in 899°C cyclic hot corrosion test.

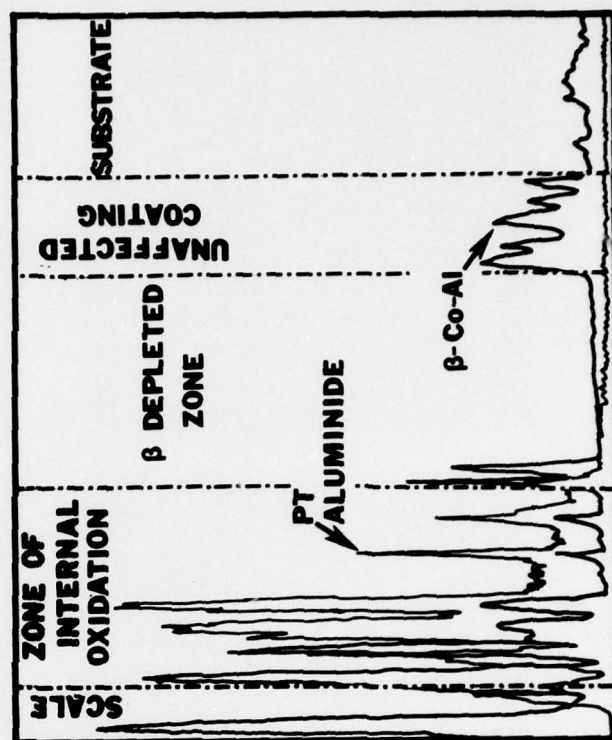
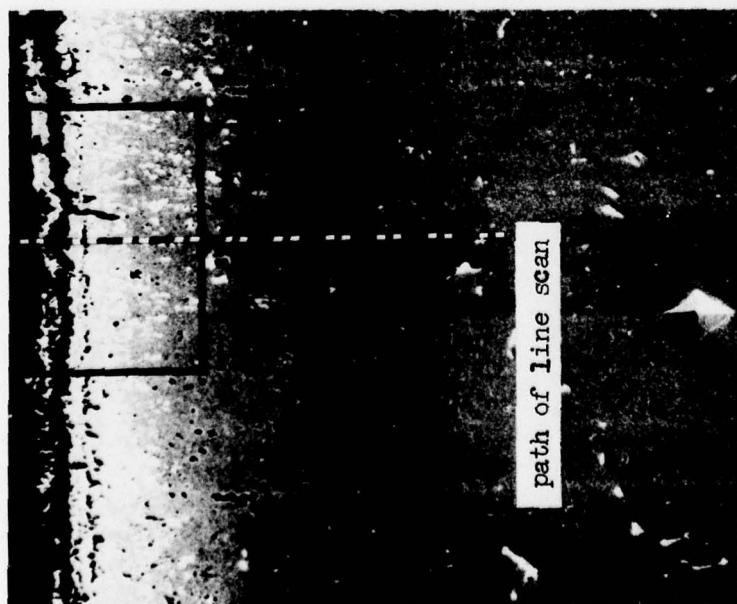
Figure 59. Degradation of Pt overlayer + PWA 68 coating produced by 700 hours in the cyclic hot corrosion test at 899°C. Break-up of originally continuous platinum aluminide phase in the overlayer (see Figs. 57c, 58) apparently exposes the CoCrAlY to dealloying by the sulfate-chloride melt, as shown by  $\beta$ -dissolution, pore formation, and Al line scans through the coating.

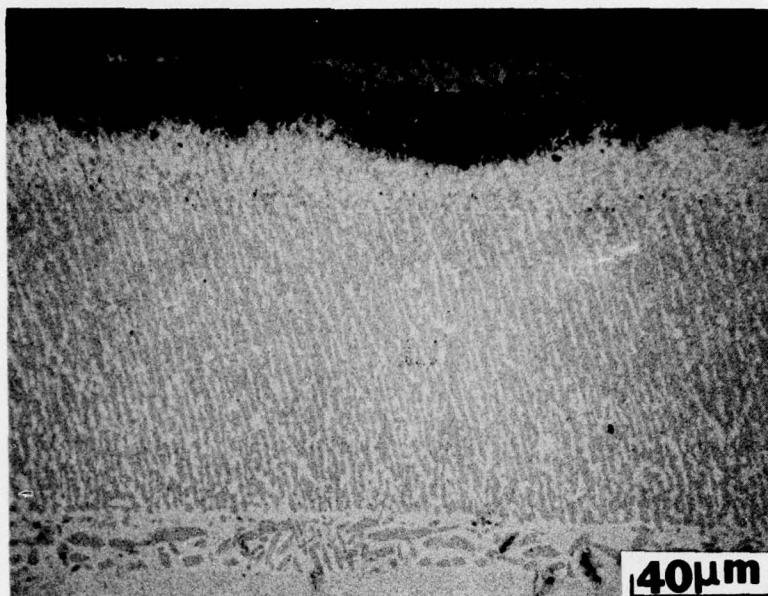
68a. typical extent of surface degradation

Figure 68. PWA 68 + Pt overlayer coating exposed 100 hours at 649°C (1200°F) with  $\text{Na}_2\text{SO}_4$  salt deposit and  $\text{SO}_3$  gas.

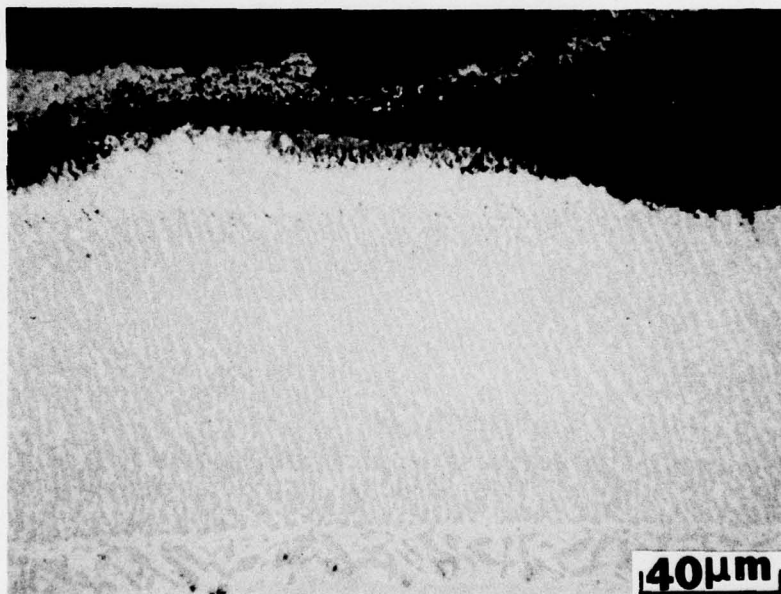
68b. spallation of oxidized overlayer

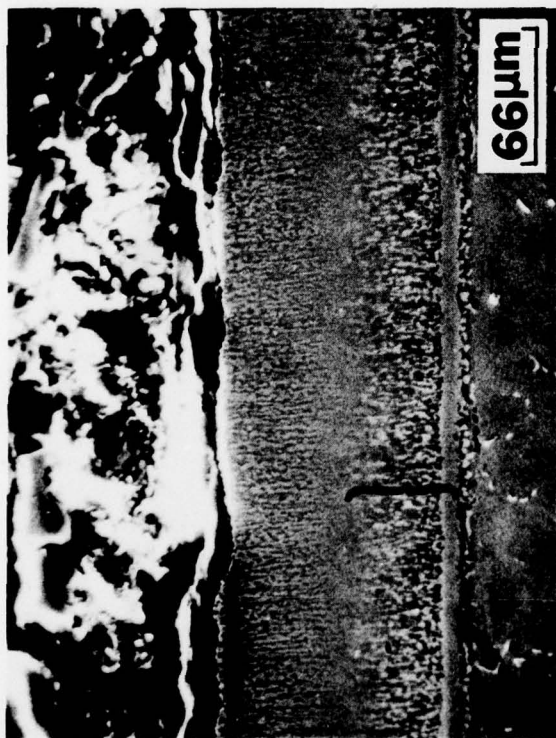
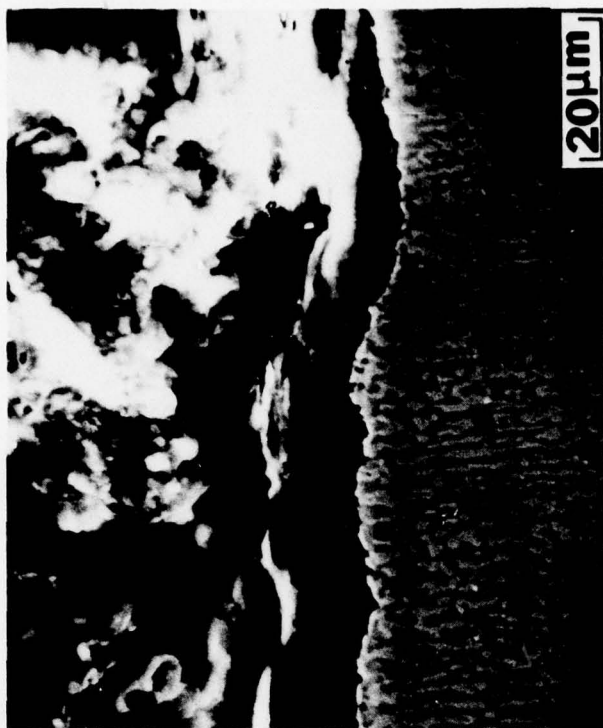
Figure 69. Secondary electron images of Pt underlayer + PWA 68 CoCrAlY coating after 100 hours at 649°C with  $\text{Na}_2\text{SO}_4$  salt and  $\text{SO}_3$  gas. Note complete absence of a diffusion zone at the attack front (as in Fig. 67), which has not penetrated to the underlayer (arrow) or Pt-containing diffusion zone (bracket).
